## EON ONE Compact Bluetooth® Button Replacement

EON ONE Compact Power Button Replacement

CN125410

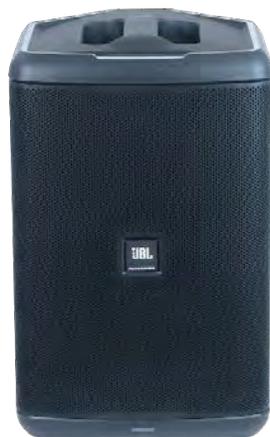
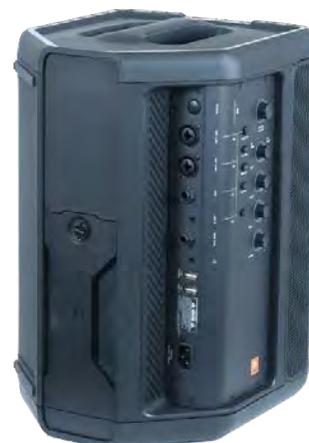
**Add:** **PN 5131522-00** HDW,GSKT,EVA,BTBTN,EON ONE COMPACT

**Replace if bad:** **PN 5125363-00** HDW,SWCAP,CHANNEL BUTTON,EON ONE COMPACT

**Replace if bad:** **PN 5125369-00** SW,PBTN,KFC-A06-01B-50-160

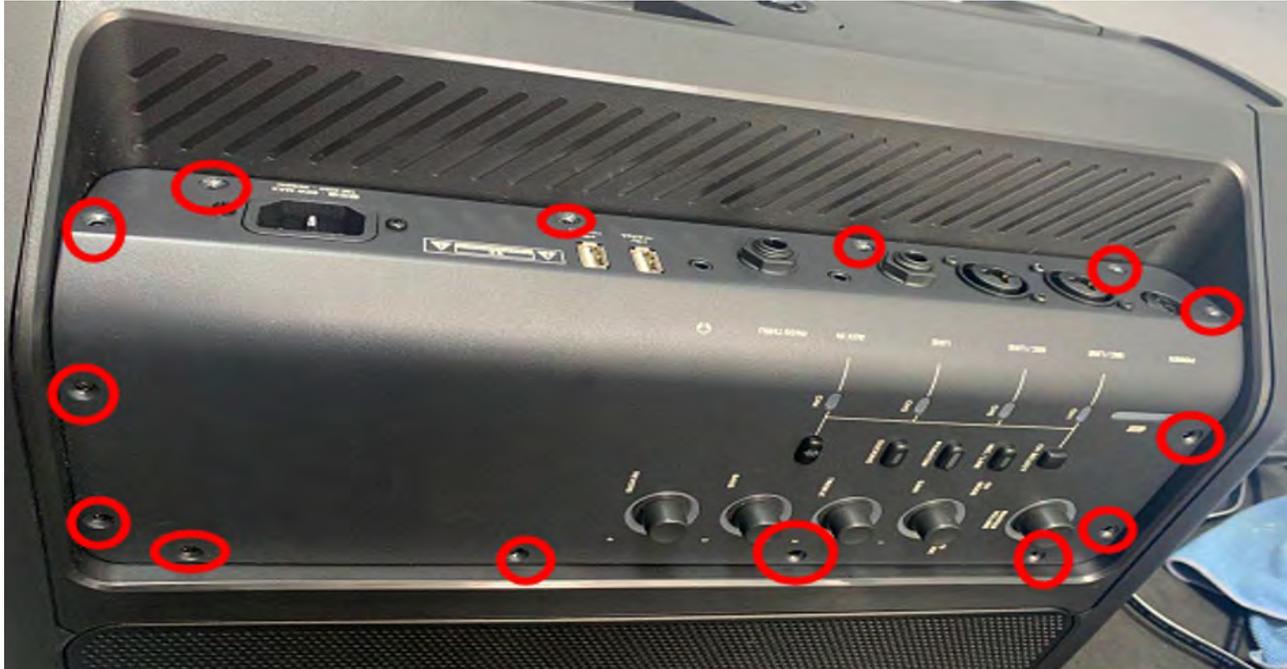
Step 1: Remove the 14 screws holding Amplifier to speaker cabinet.

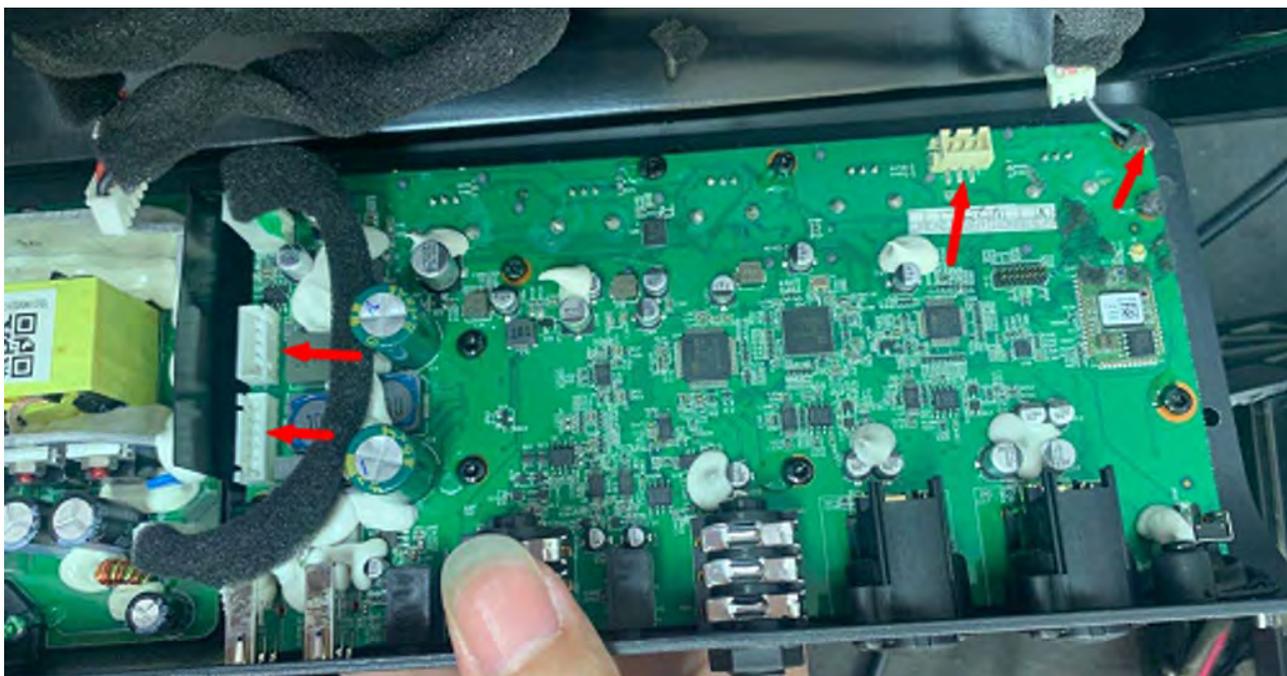
Step 2: Remove all cables from Main PCBA.

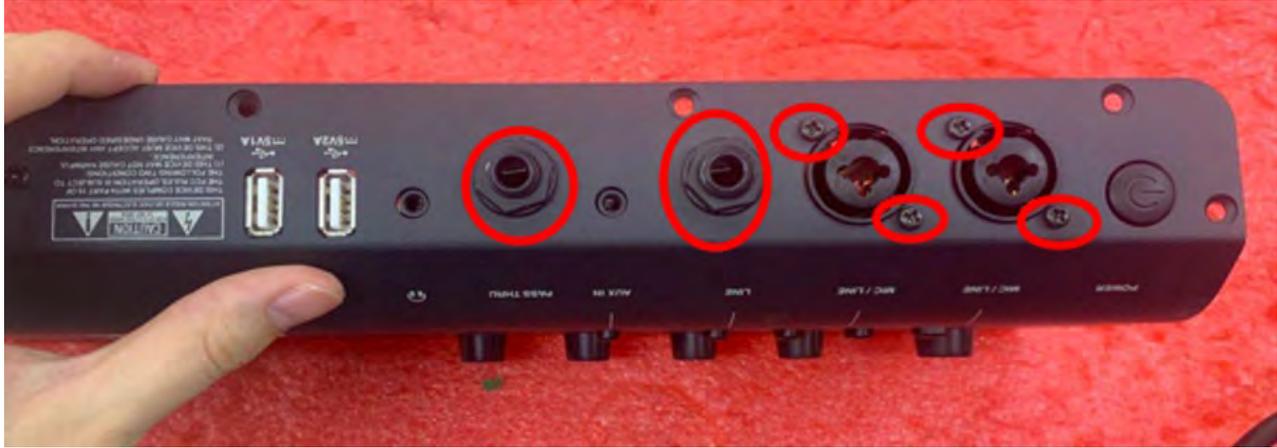
Step 3: Remove the input connector screws, and 1/4" nuts.

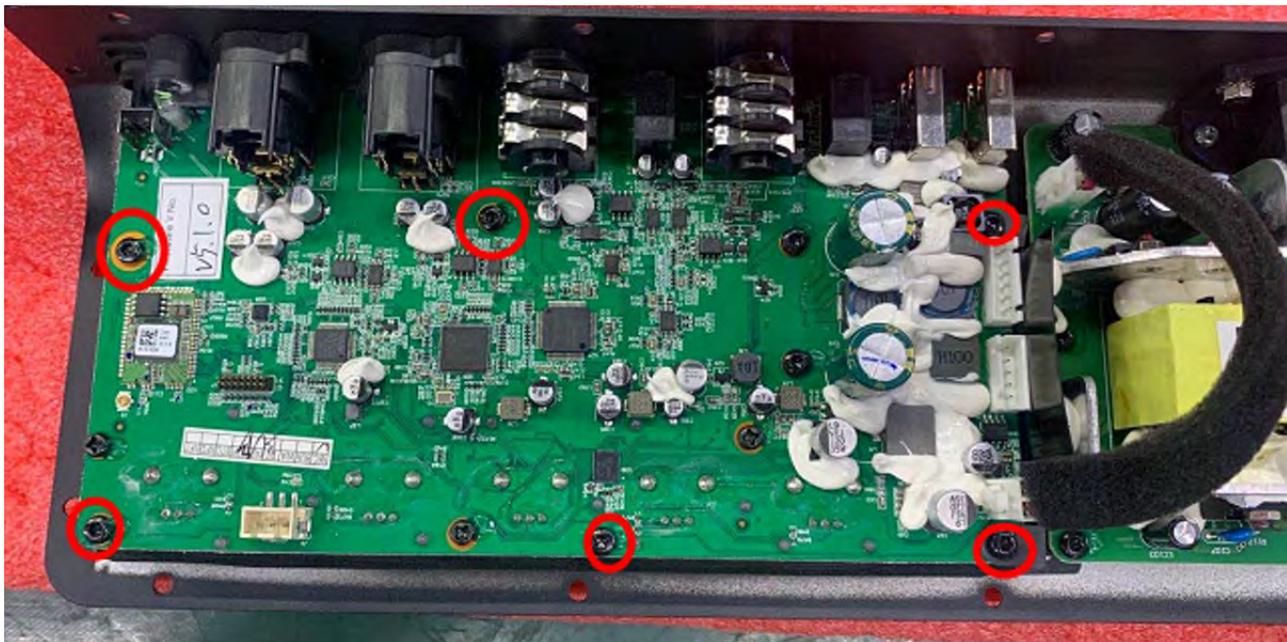
Step 4: Remove the 6 screws holding Main PCBA to amp chassis.

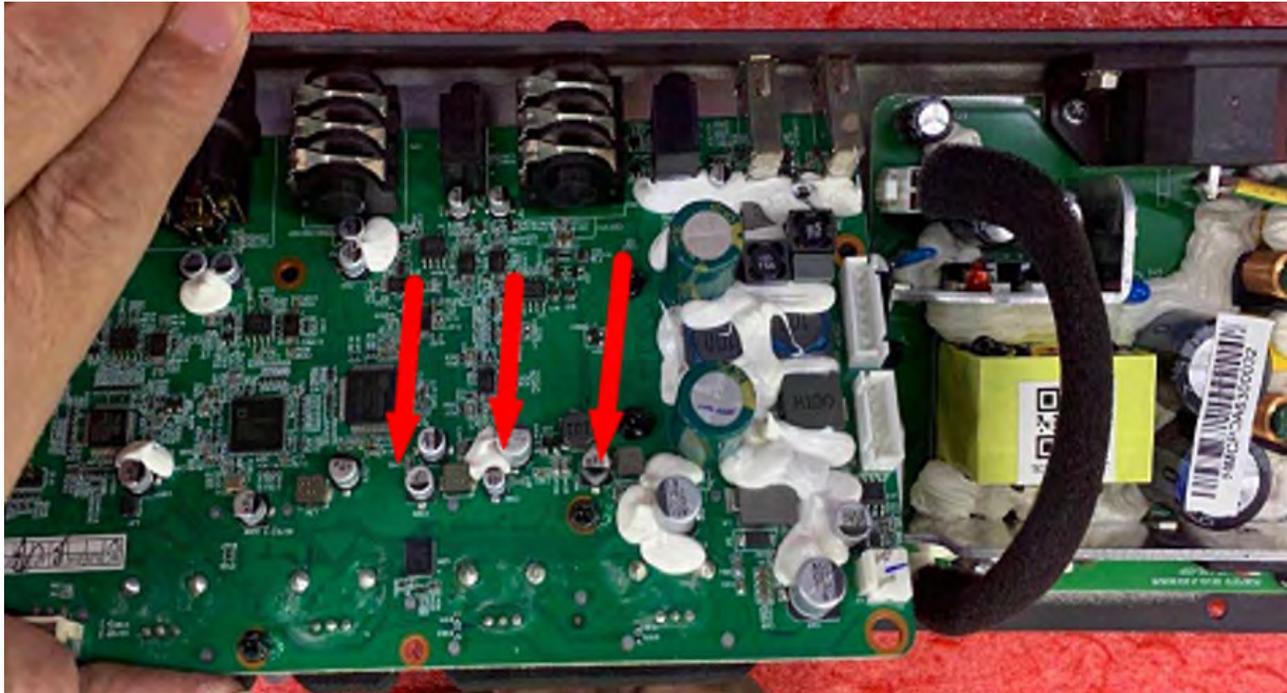
Step 5: Remove the Main PCBA from Amp chassis.

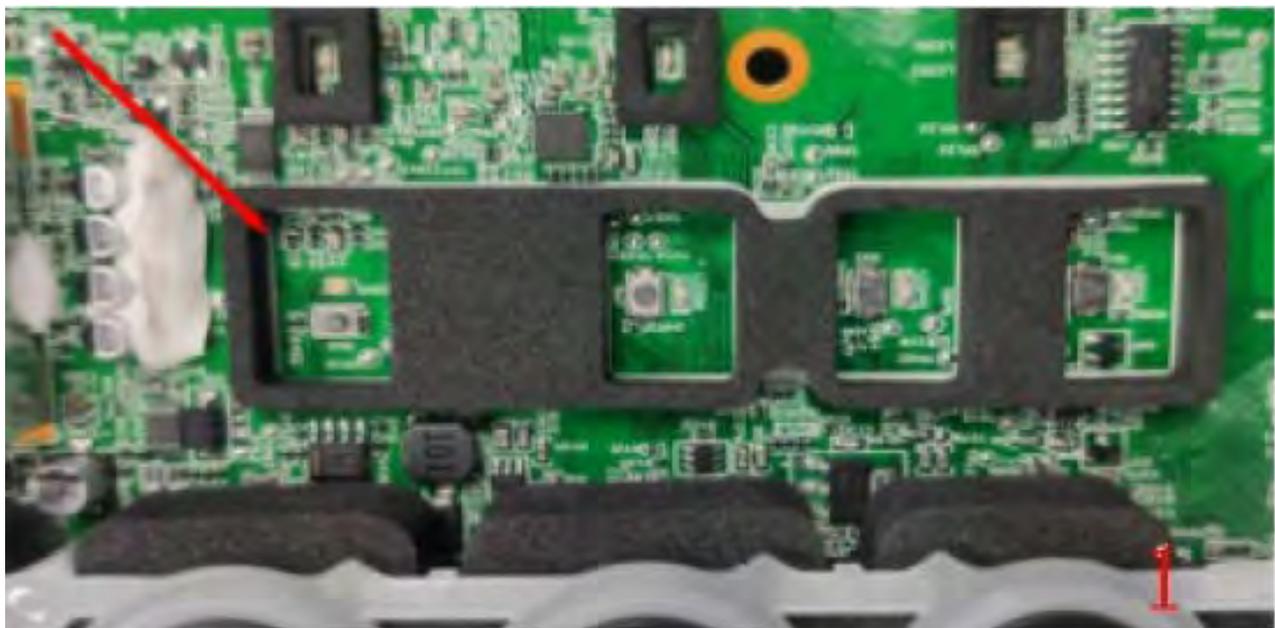
Step 6: Remove the original EVA

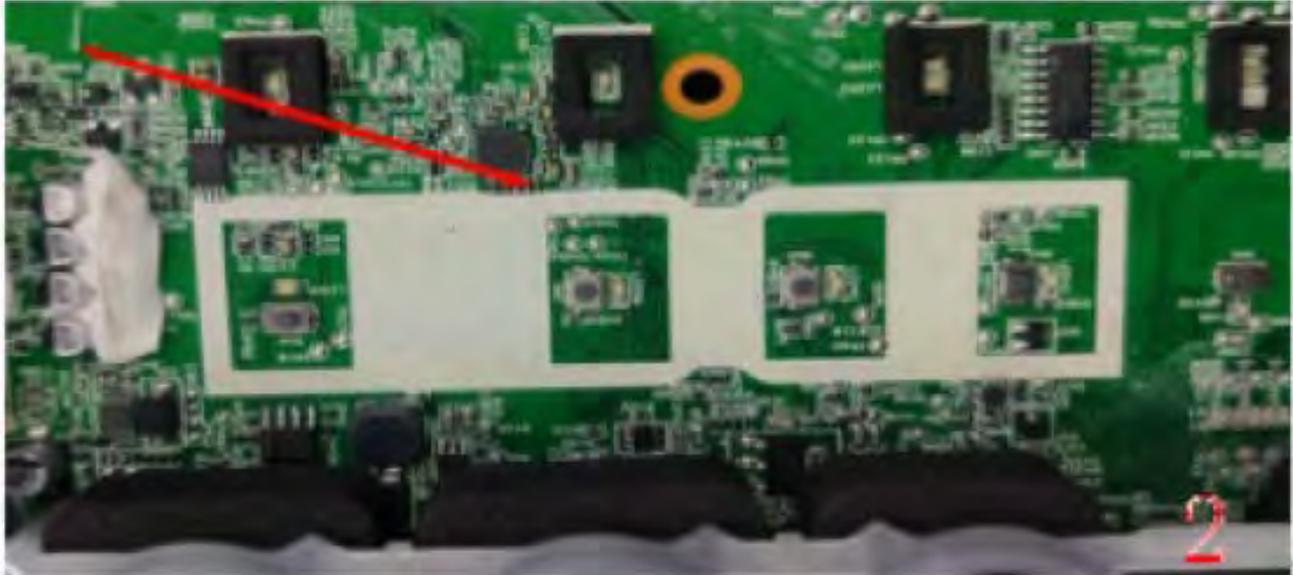
Step 7: Confirm whether the tact switch of BT button is damaged.

- If no, please skip step 8 and go to step 9
- If yes, continue with step 8 to replace the switch:

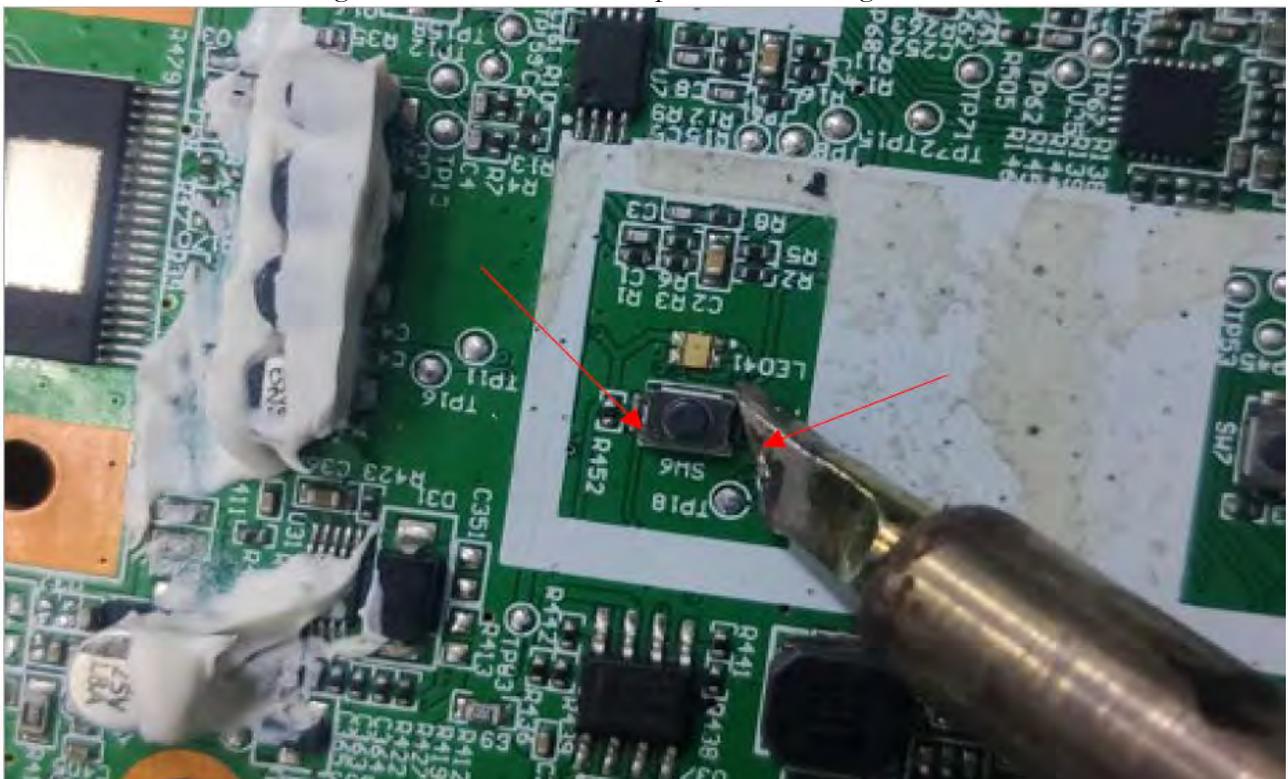
1) Place the soldering iron on the PCB and heat evenly until the solder melts. Remove the tact switch. Take care that the soldering iron does not touch the parts surrounding.

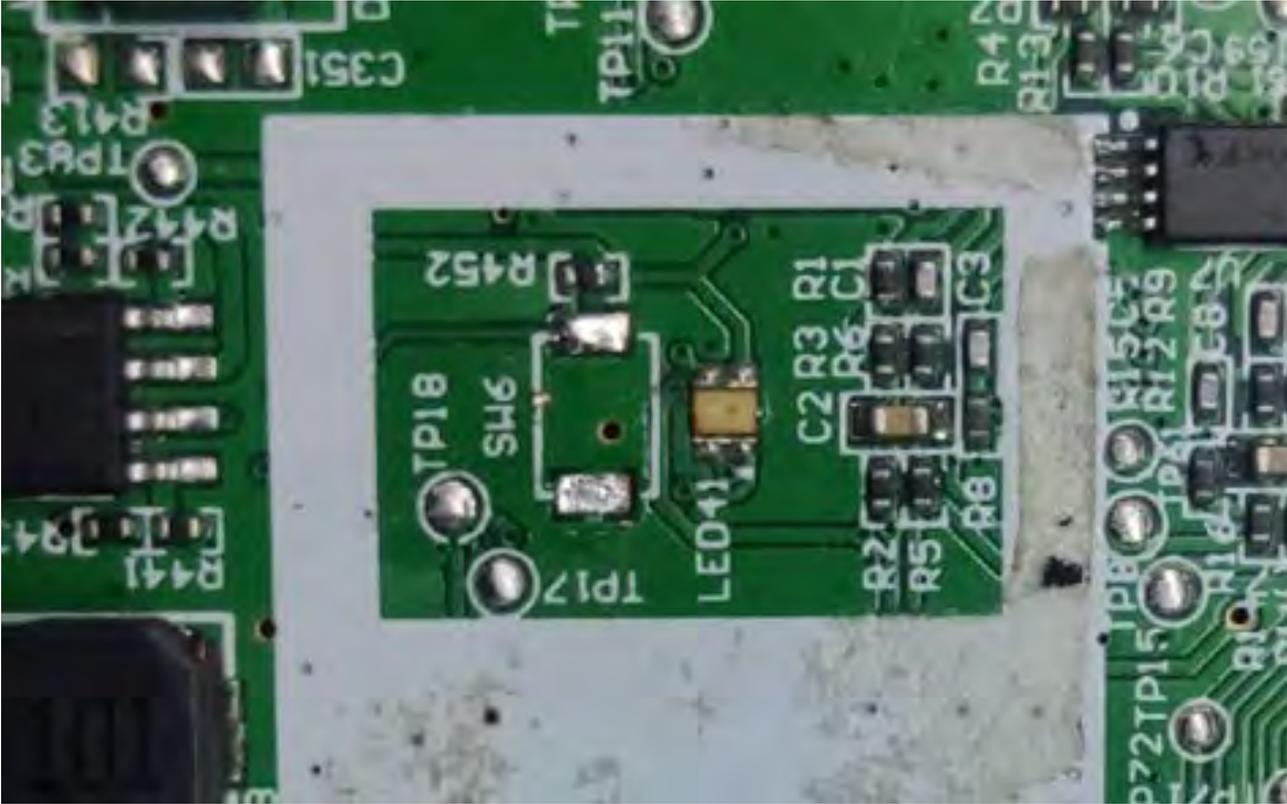
2) After you remove the tact switch, clean PCBA with Isopropyl Alcohol 90% or higher.

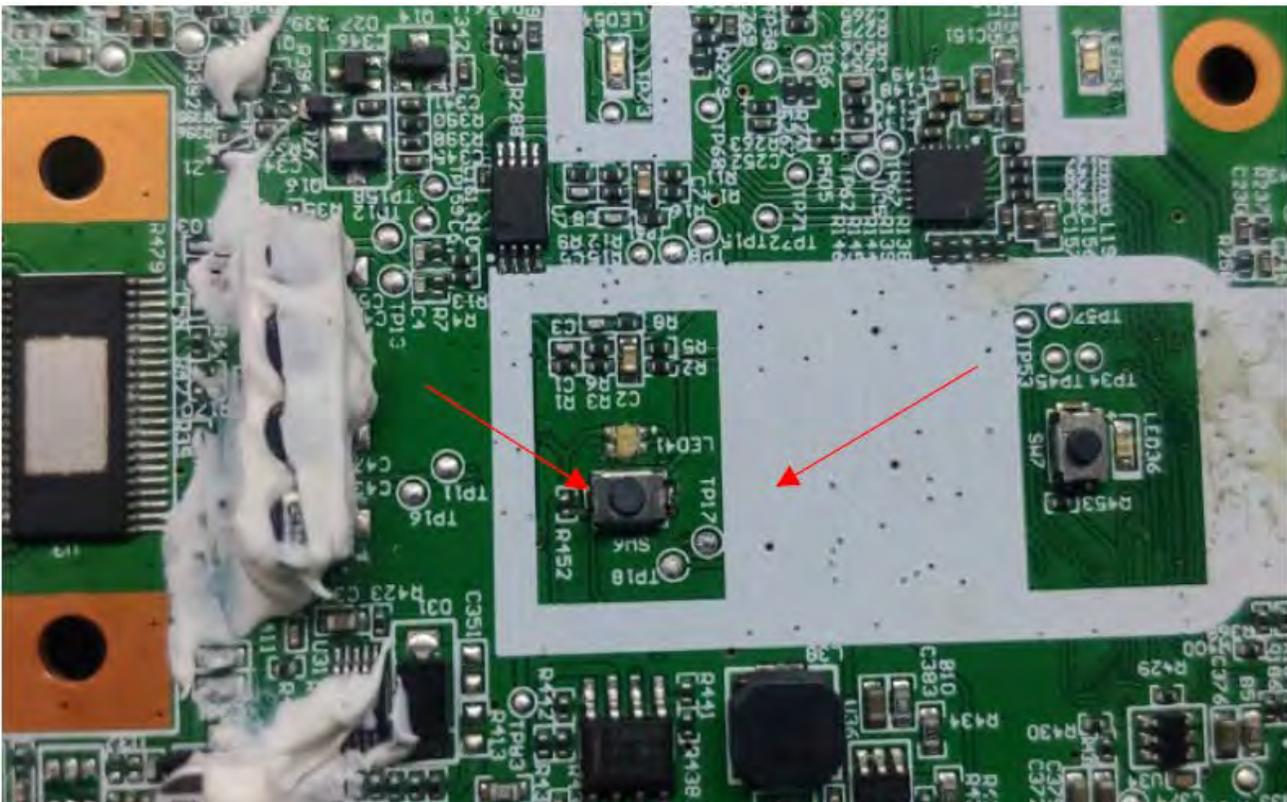
3) Place the tact switch according to positioning line, and solder switch to PCB.

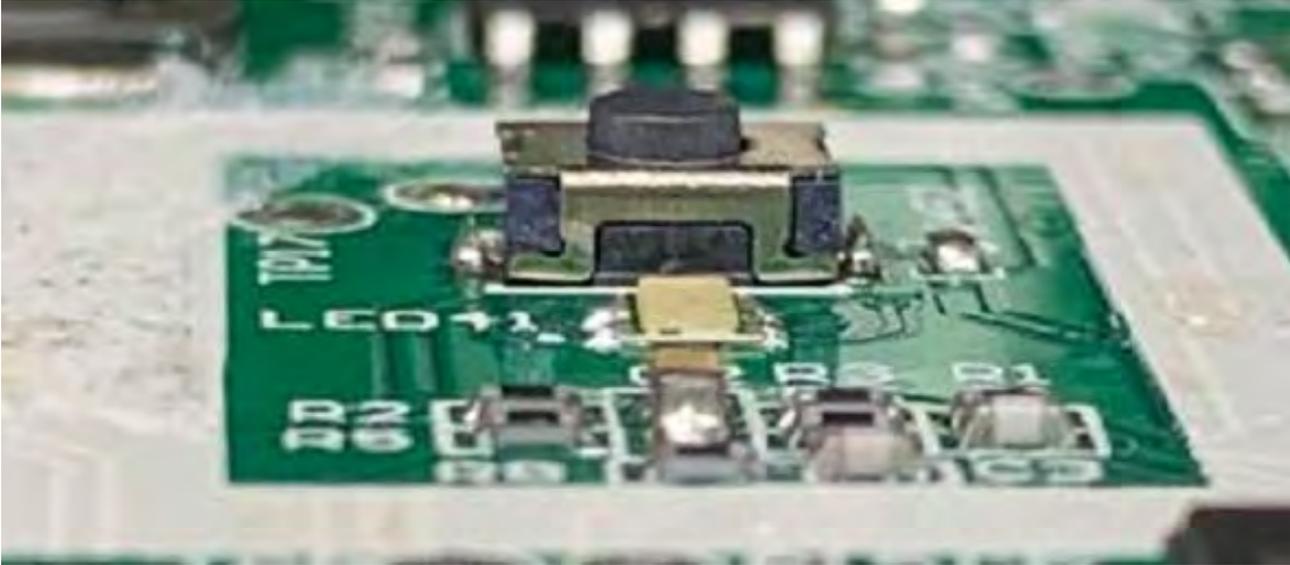
- Inspection:
1. Tact switch soldered flat on the PCBA
  2. Clean PCBA with Isopropyl Alcohol 90% or higher.

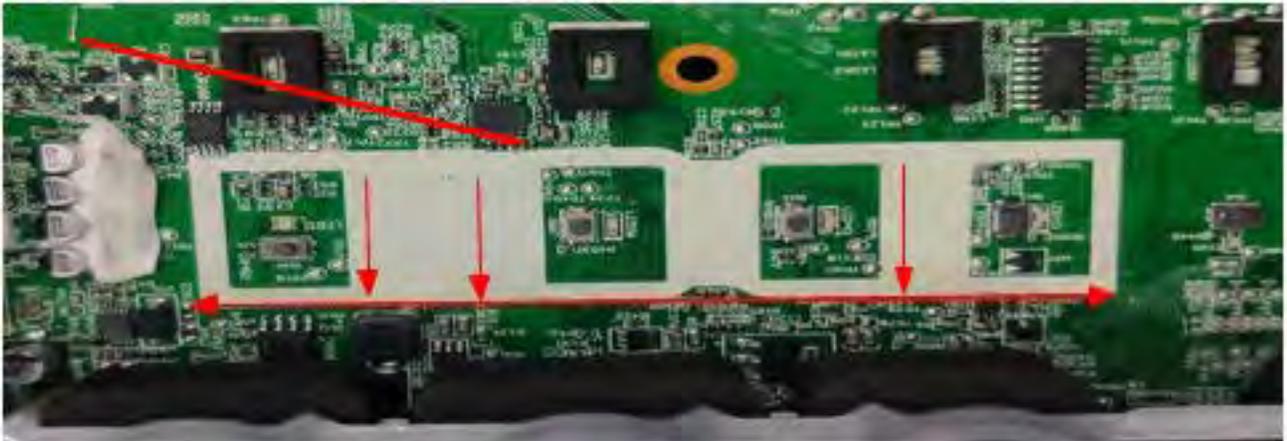
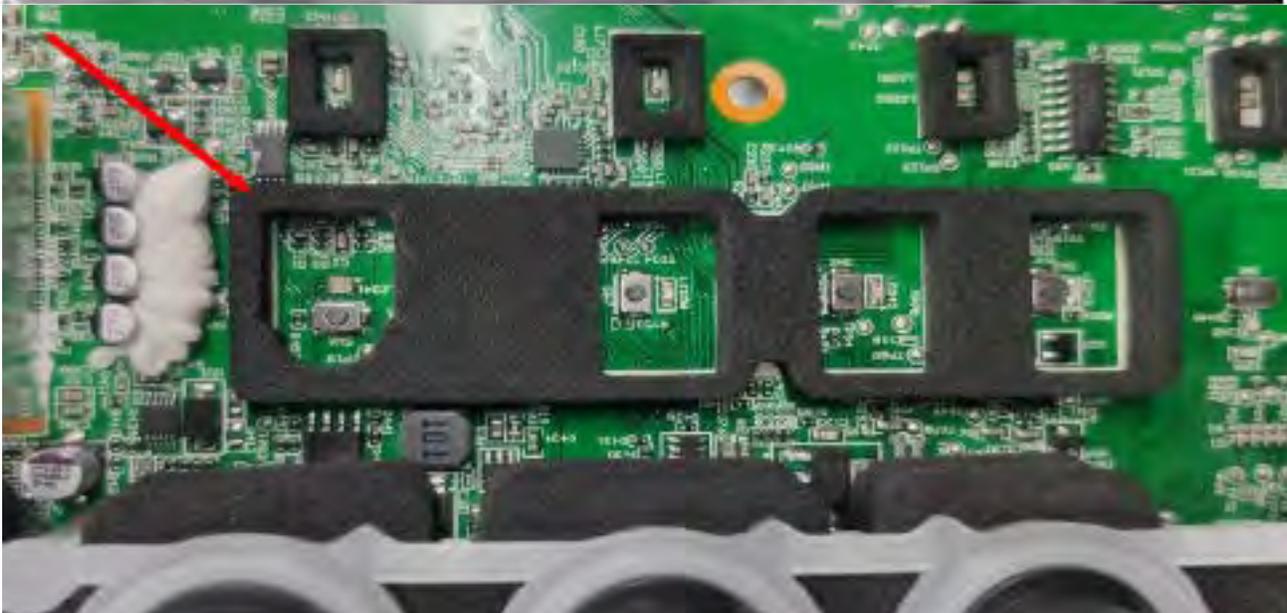
Step 9: Place new EVA gasket on the PCB as close as possible to the following red line.

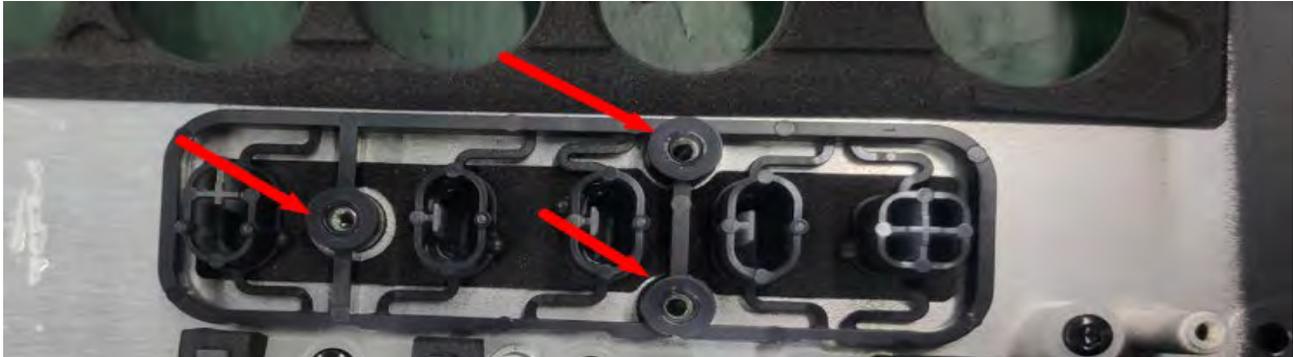
1) Remove the 3 screws holding button assembly to chassis.

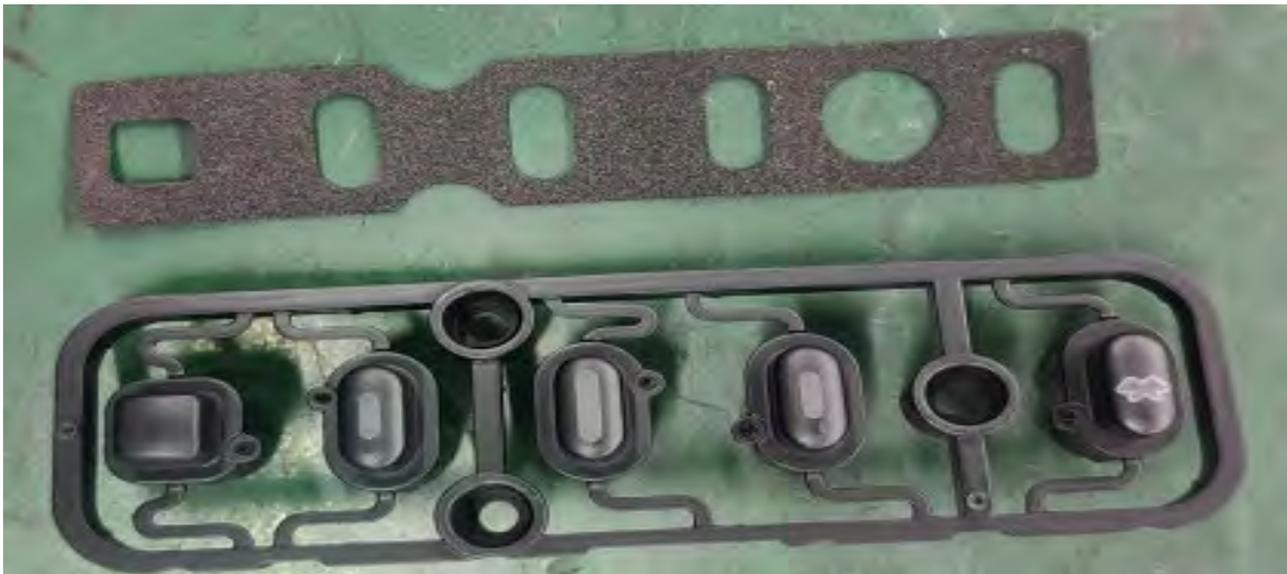
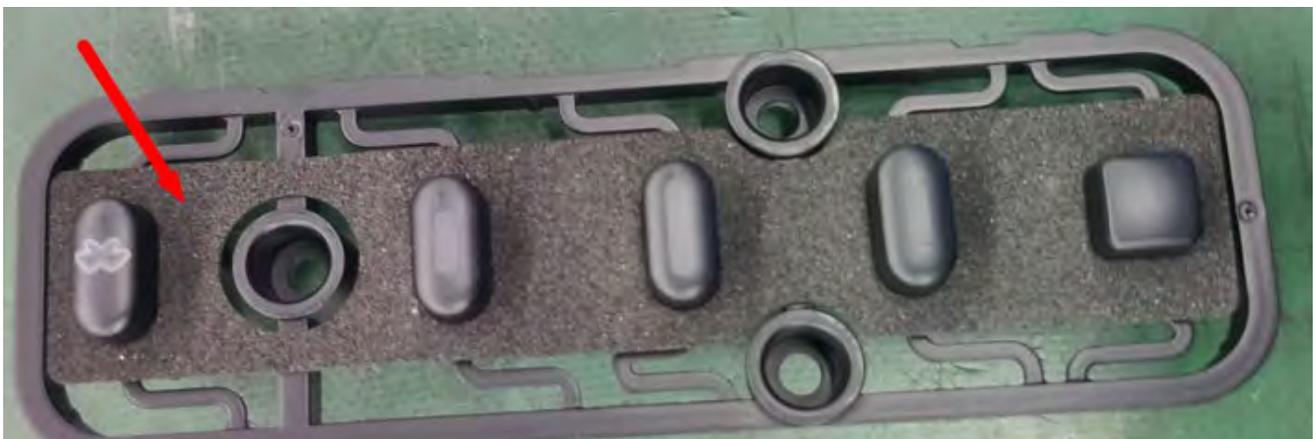
2) Move the button assembly EVA gasket to new button assembly.

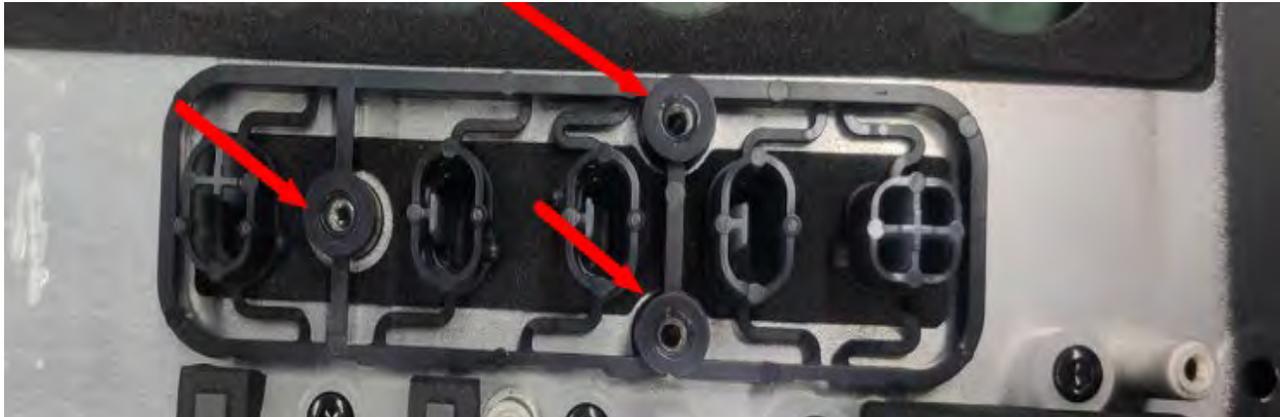
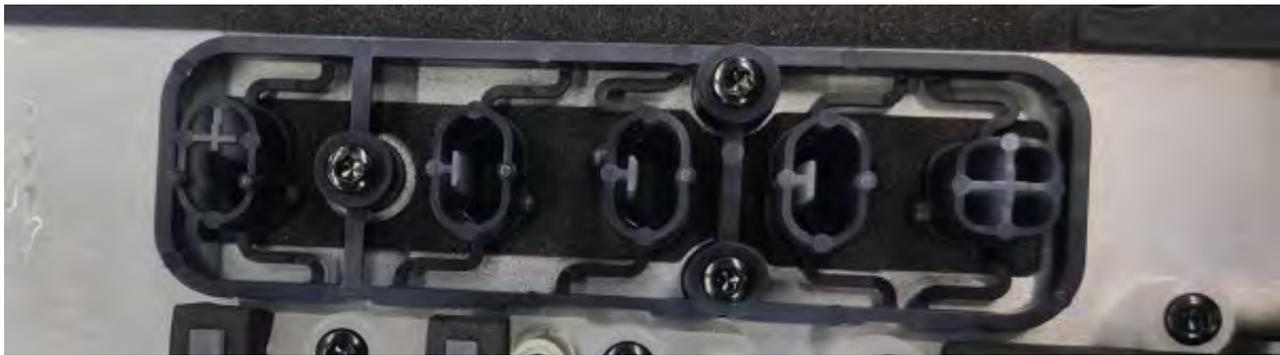
3) Re-secure the button assembly to chassis using the 3 screws previously removed.

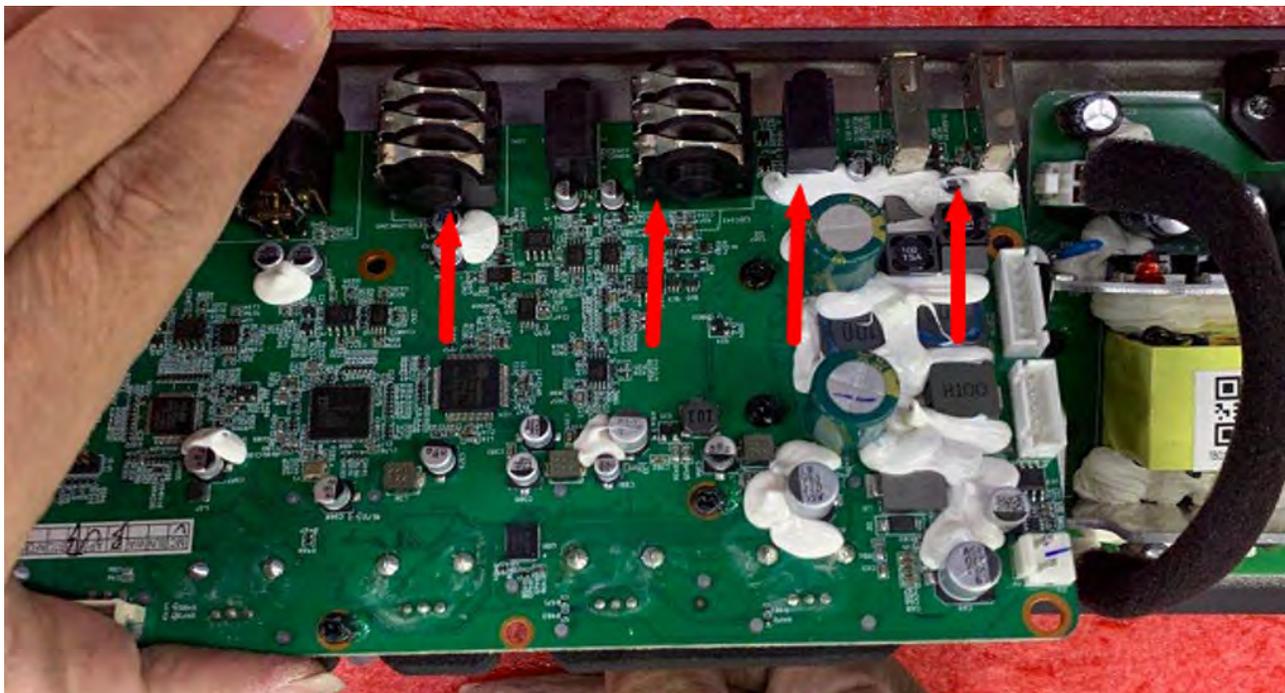
Step 12: Insert Main PCBA to Amp chassis .

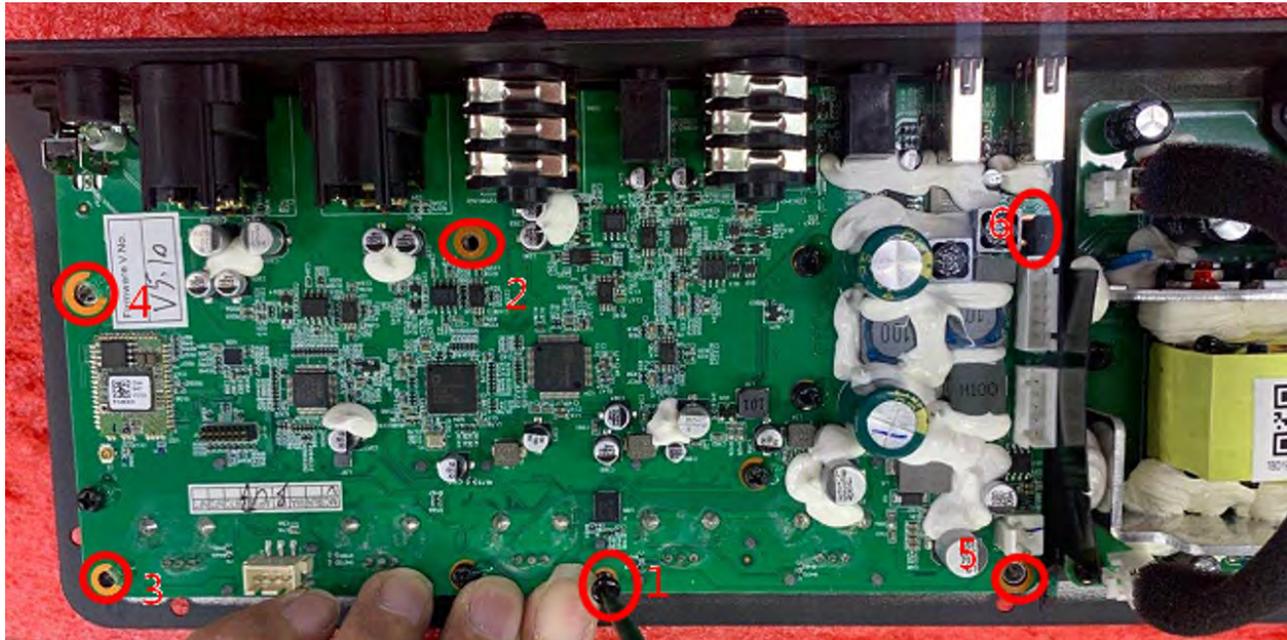
Step 13: Secure the Main PCBA to amp chassis using the 6 screws in the following sequence..

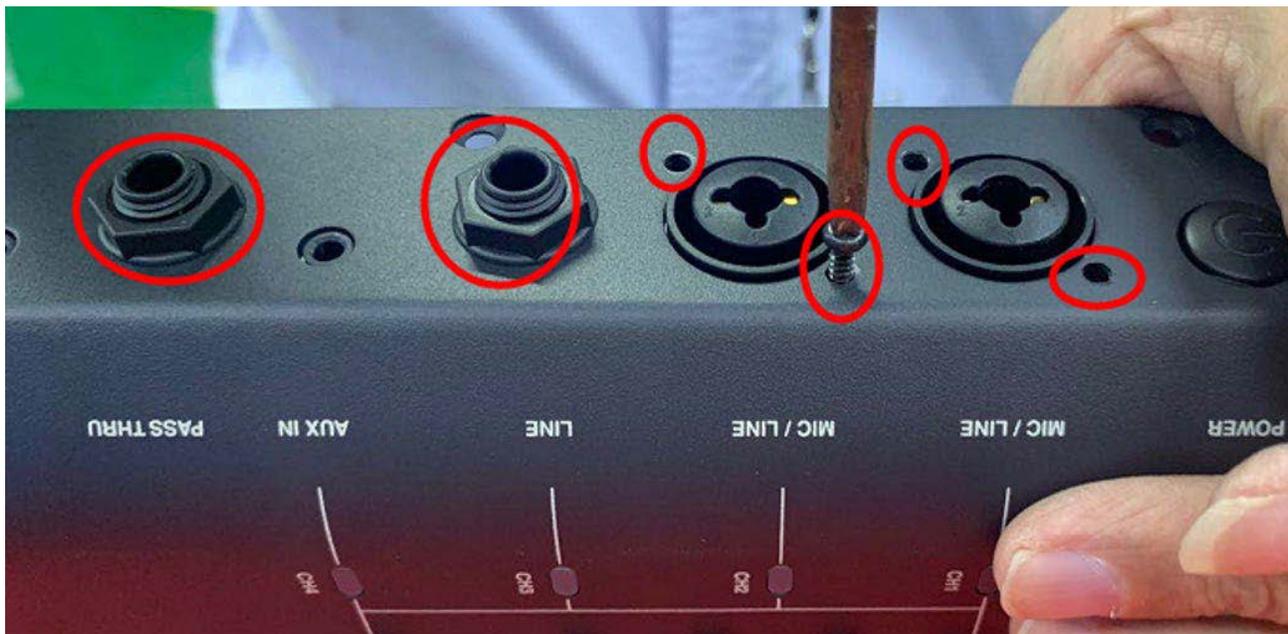
Step 14: Verify the BT button moves freely, and the tact switch is engaging and releasing correctly. Tighten the connector screws and 1/4" nuts. Now check the BT button, and tact switch again to make sure both are still working correctly.

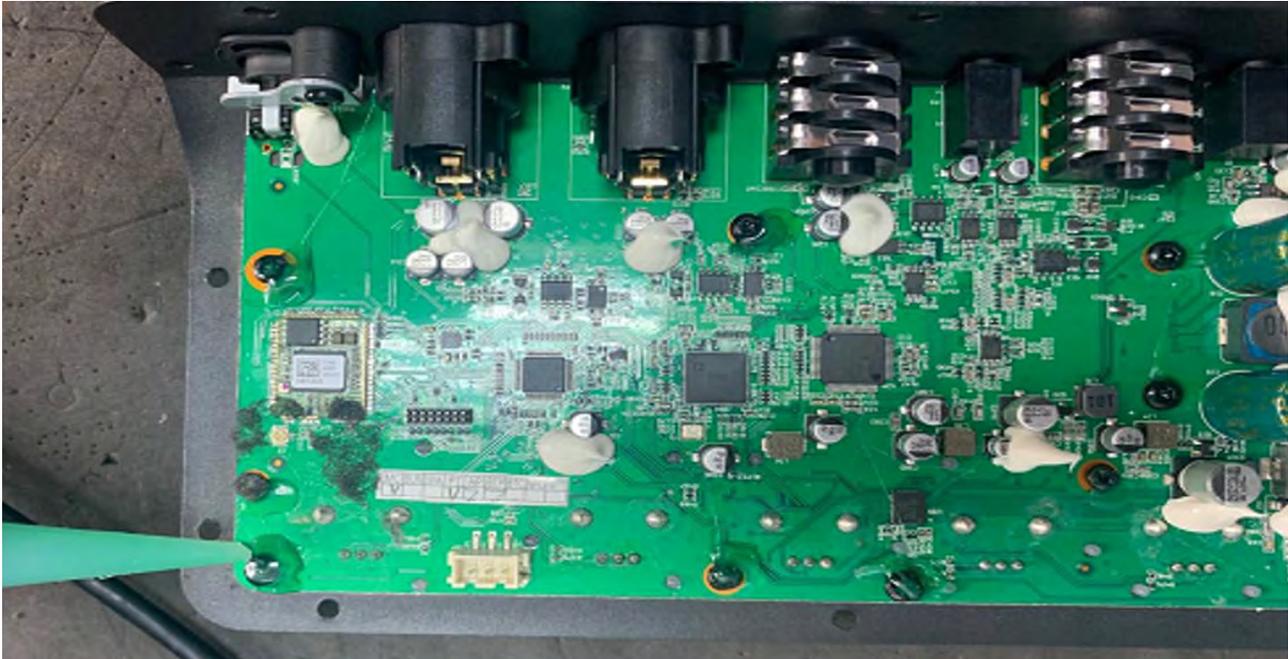
Step 15: Use locktight to keep the screws from backing out from vibration.

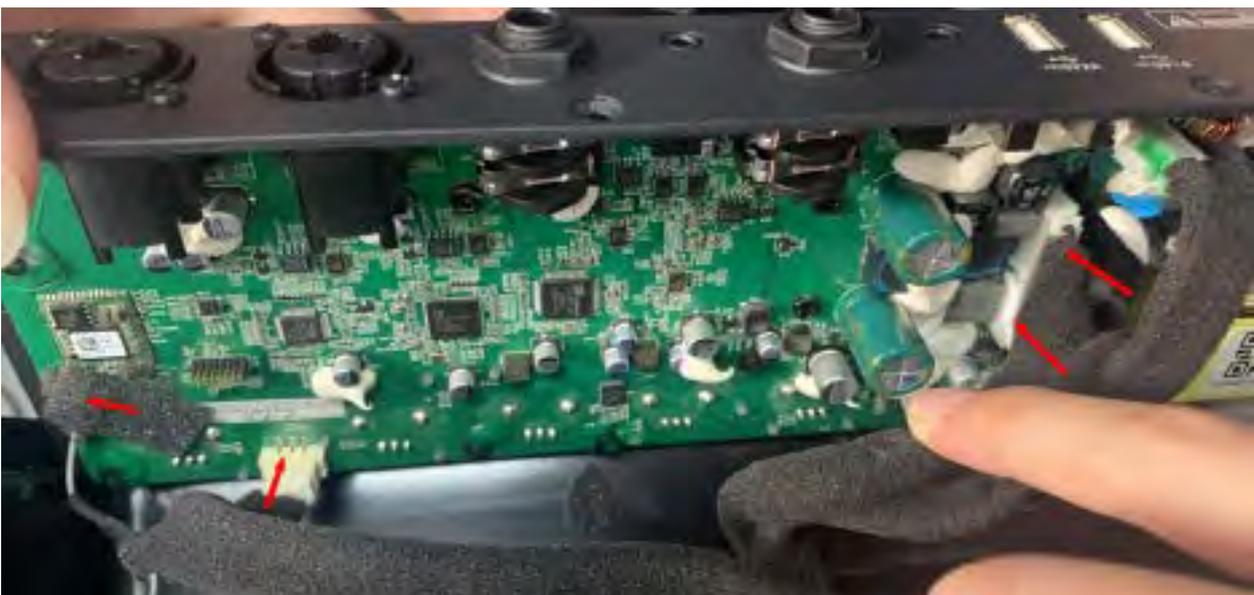
Step 16: Re-connect all cables.

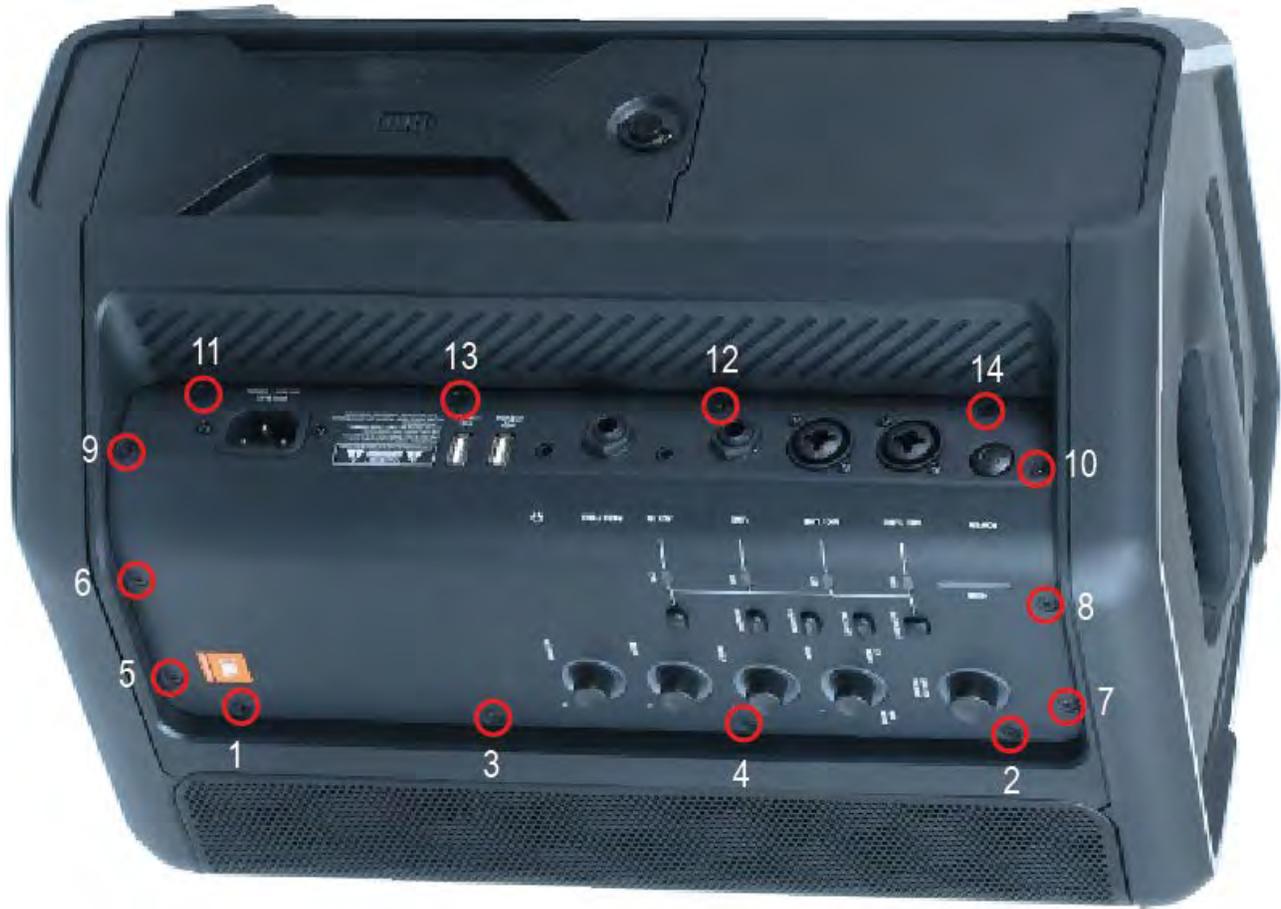
Step 17: Position the Amp Assy back into place with the Compact SPK, and tighten the screws in the following sequence. You are now ready for final testing to verify correct operation.
